HOST UNIVERSITY: University of Edinburgh

DEPARTMENT: Fire Safety Engineering

**Study on the burning behaviour of green walls with reduced moisture content**

**International Master of Science in Fire Safety Engineering**

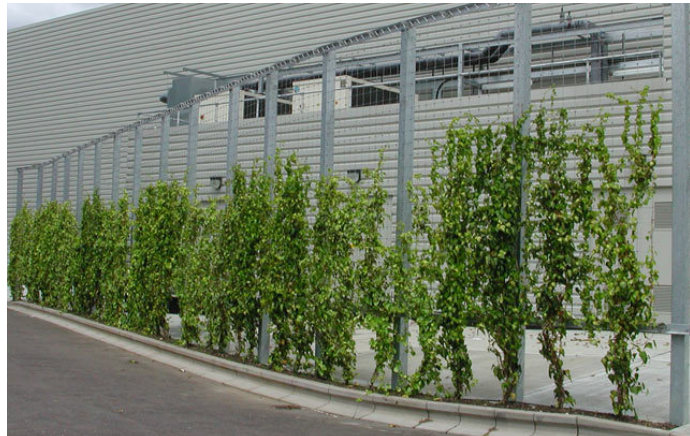
**Figure 2: Climbing Plant Wall (Jakob Webnet , 2021)**

rooted in both the ground and elevated soil planters. They do not necessarily need an irrigation system to survive, although many have them. The benefit is they are able to use non-flammable materials to form the trellis, such as steel cable, and they are not subject to erosion. The downside is there are limited varieties of plants to choose from, and the continuous vertical plants make fire breaks difficult to implement.

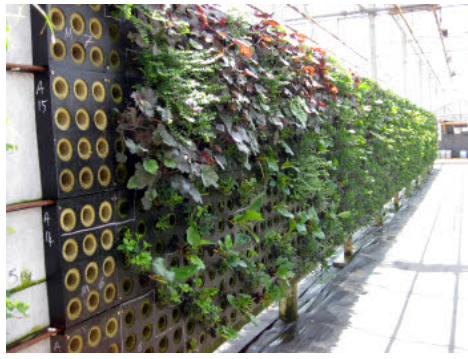
**Figure 3: Hydroponic Wall (Willerby Landscapes Ltd)**

2. Hydroponic wall. Accomplished using an artificial growing medium instead of soil. Examples include plastic mesh, mineral wool, and fabric. They instead require an irrigation system with nutrients mixed into the water to keep the plants alive. The benefit is they are not subject to erosion, and a wide variety of plants can be used. The downside is the growing medium could have fire properties that are worse than standard soil, and it can be costly to maintain the constant supply of nutrients needed by the plants.

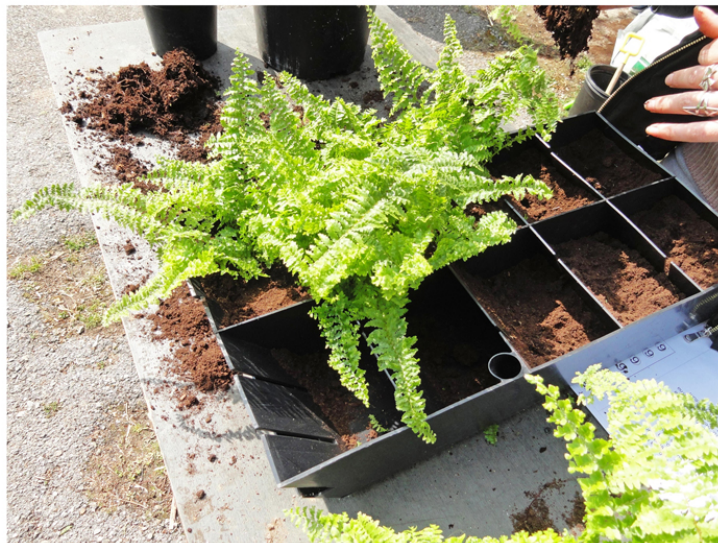
**Figure 4: Modular Green Wall Panel (RR Landscape solutions Ltd)**

3. Modular Green Walls. Accomplished using prefabricated modular panels with cells for the individual plants and soil. They are usually made out of a lightweight plastic or fabric, and are fixed to the wall or frame of the structure. An irrigation system is usually required, but the nutrients can be added to the soil directly, if desired. The benefit of this system is they have a considerable amount of soil, which can act as thermal ballast in a fire scenario if it is sufficiently watered, and they can incorporate a wide variety of plants. The downside is the module material can be flammable, the soil is at risk of erosion due to its vertical orientation, and the panels can be quite heavy.

From this list, the modular green wall system was chosen for this study. The rationale was that they have most of the aforementioned fuel sources represented in the system. They are also soil based, so there would be less

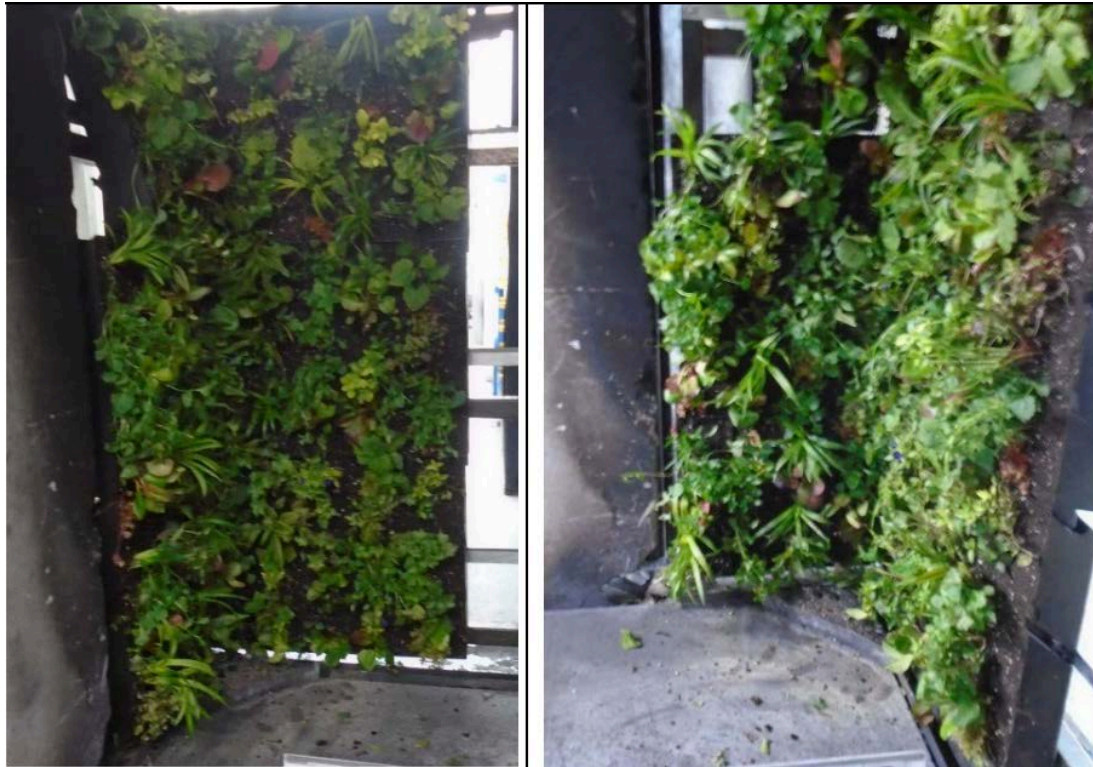
**Figure 6: Green Wall SBI Test (Dale, 2021)**

permitted to use fully living plants, which will have a relatively high moisture content, both in the canopy and soil. This could act as a thermal ballast and slow the spread of fire. Therefore, this testing scenario assumes that the green walls are adequately watered and maintained, which is not necessarily the case.

There are other issues with testing a green wall system in the SBI framework, as well. The BS EN 13823 test requires that the specimen be conditioned to a temperature of  $23\pm 2$  °C and a relative humidity of  $50\pm 5\%$ , either for a fixed period of time or until it achieves a stable mass. Because the specimen is a living plant, a constant mass is essentially impossible to achieve. Also, a steady supply of water is needed to keep the plants alive, which would alter the relative humidity. Therefore, it is not possible to conduct a valid SBI test under the current rules. However, several manufactures have chosen to conduct the test purely for demonstrative purposes. (Dale, 2021) To my knowledge, none of them have attempted the test using plants that have been intentionally left dry, leaving this a relatively unexplored area.

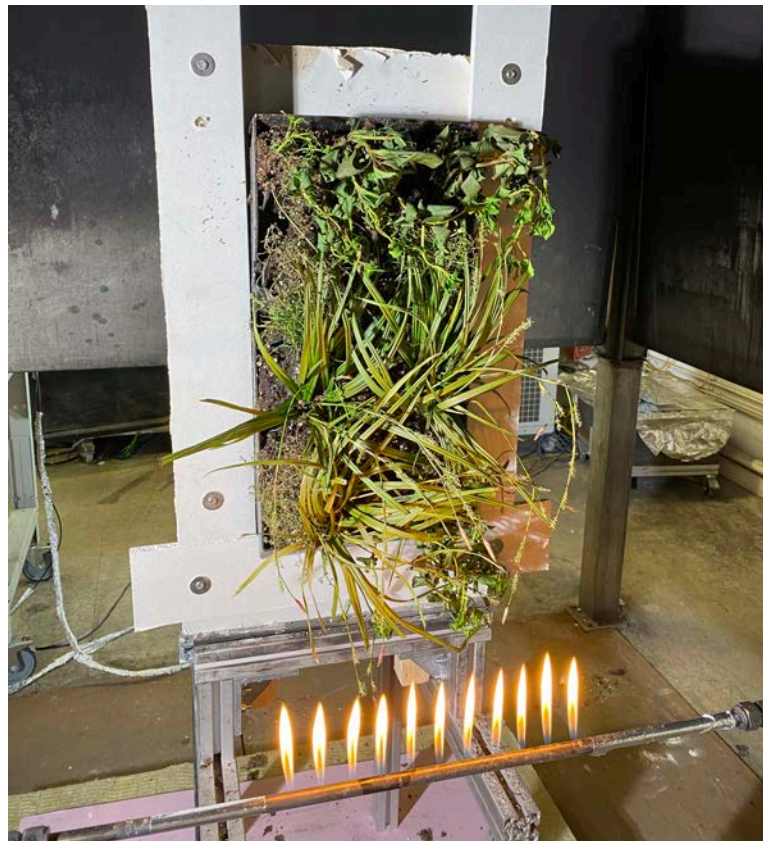
**Figure 10: Pilot Flame**

The module was then mounted to the stand using screws. The flame source for this experiment was a lateral propane igniter with a series of eleven holes to distribute flame evenly across the bottom of the module. The propane flow was set to 0.04 g/s, which translates to a roughly 1.85 kW fire. (Drysdale, 2011) This is referred to as the pilot flame.

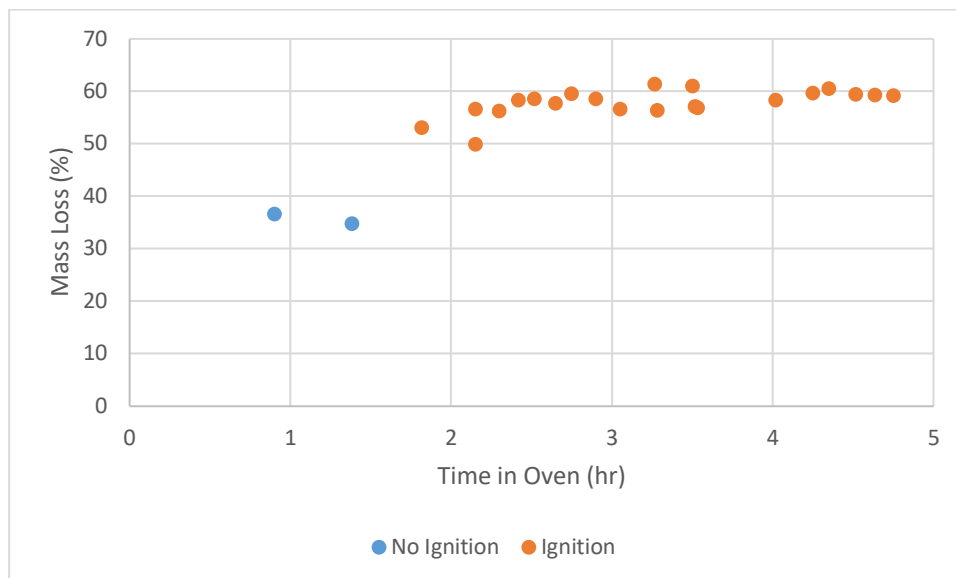
**Figure 11: Pachysandra Leaf Data**

The results of these tests were in line with the expectation that more time in the oven results in more mass loss, as shown in Figure 11. However, the mass loss seems to plateau after approximately 2 hours, even though their flammability continues to increase. The samples reached flammability after **2 hours** in the oven. These samples can be identified in the raw data in the appendix by the letter 'P' in the plant ID.

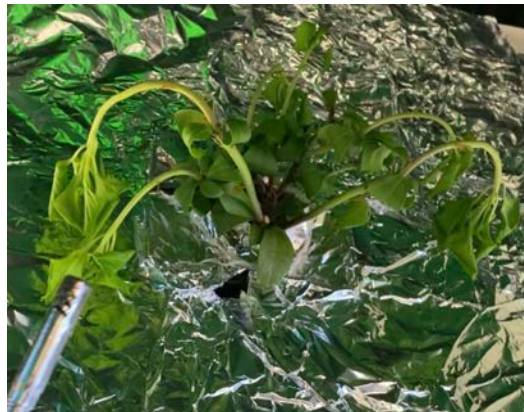
**Figure 16: Pachysandra Terminalis**

The raw data of these plant tests is available in the appendix, where they can be identified by the 'G' prefix in the test ID. See Figure 16 for a photo of the plant shortly before testing began.

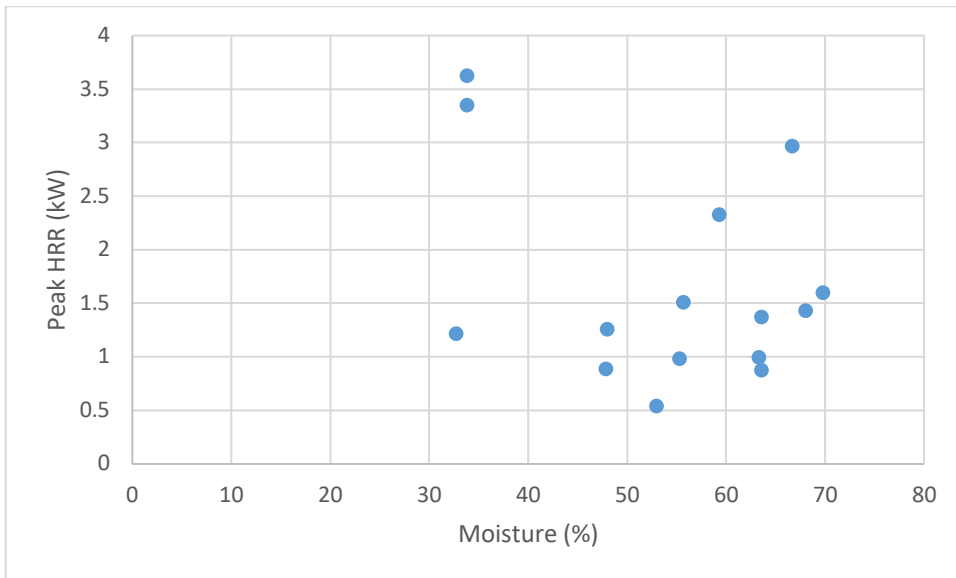
**Figure 19: Pachysandra Peak HRR vs moisture content**

The next goal of this experiment was to establish a relationship between the moisture content of the soil and the flammability of the plant. The issue of inconsistent moisture readings poses a significant challenge to drawing any conclusions here. Using the peak heat release rate as a discrete value to characterize flammability, the expectation is that there would be a discernible relationship between that and moisture content. However, that is not necessarily the case. See Figure 19 for a visualization of the data.

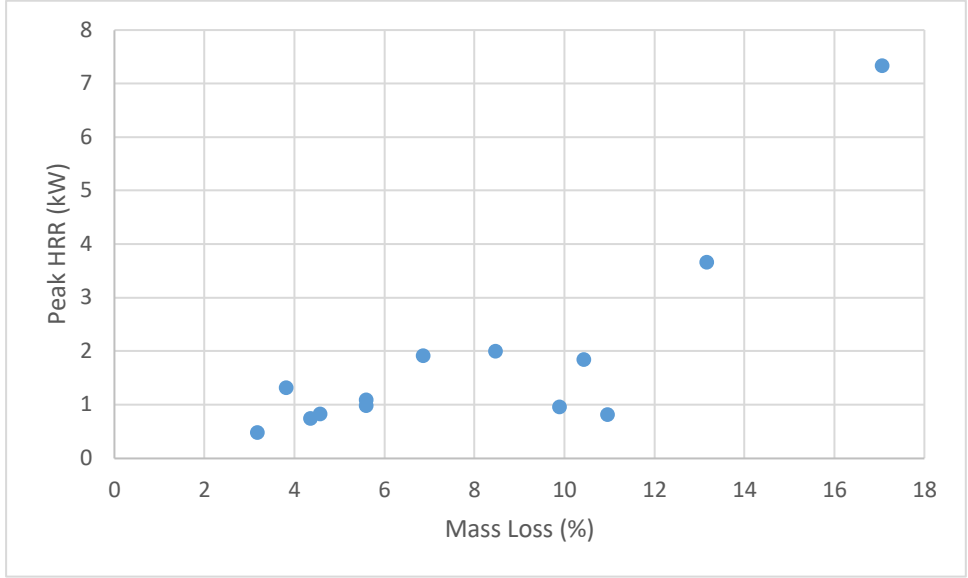
**Figure 25: Carex Mass loss vs Peak HRR**

The relationship between the percentage of mass lost and the peak HRR is also fairly reliable. See Figure 25 for details.

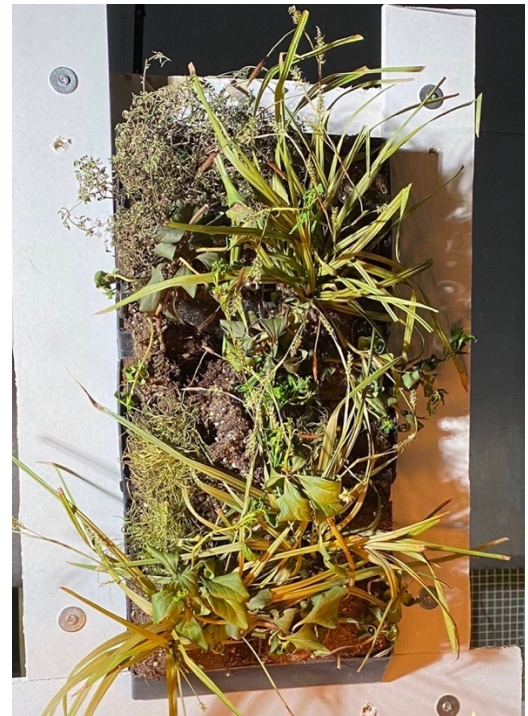
*Figure 30: Module 1, Post-dry*

Table 1: Module 1 Conditions	
Time Drying	12 hours
Post-dry Weight	5.615 kg
Percent Moisture	62.56 %
Percent Mass Lost	16.77%
Test Date	March 29, 2022

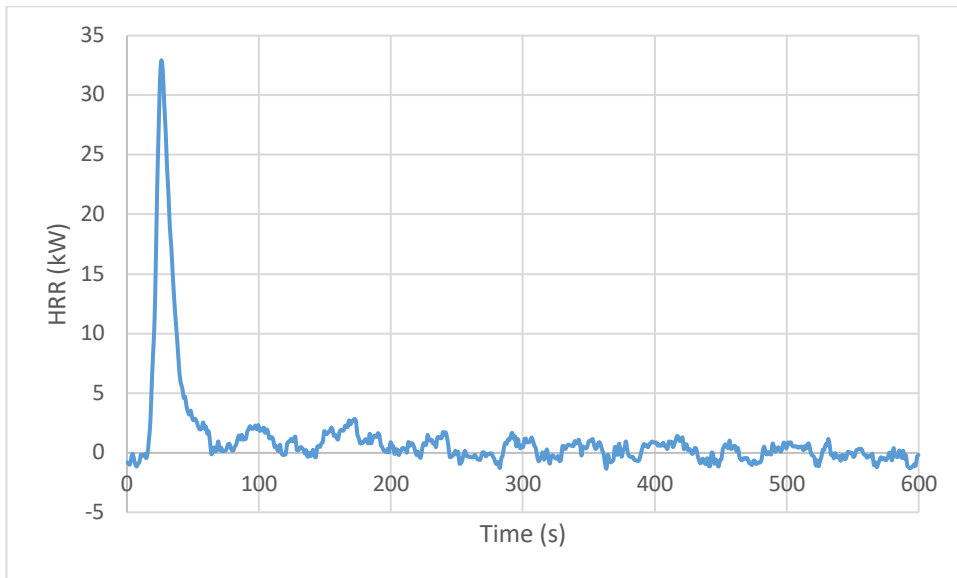
**Figure 32: Module 1 HRR**

The heat release rate for this test peaked at ~33 kW very early on in the test and then dropped to less than 1 kW, due to a complete consumption of the canopy fuel. The mass lost by the module is also fairly steep during this first phase, but it reached a steady rate of 0.14 g/s after about 1 minute. This suggests that the soil was smouldering, either from the initial canopy fire or the continued exposure to the pilot flame. See Figure 32 and Figure 33 for the relevant trendlines. Neither the flame from the canopy or the smouldering soil were able to ignite the module plastic.

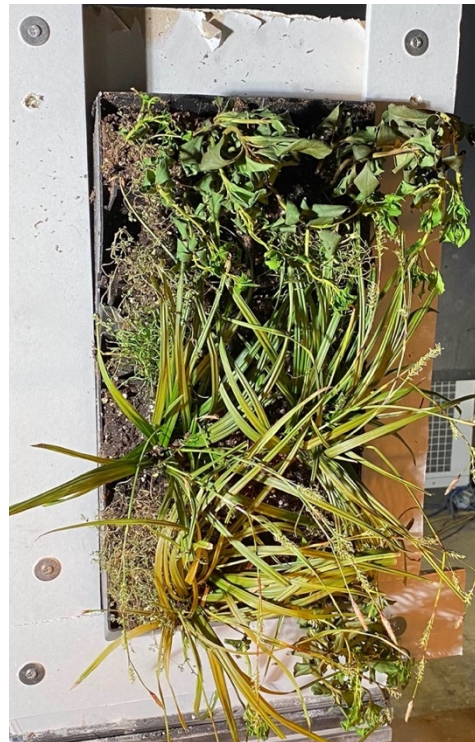
**Figure 37: Module 2, Post-dry**

<b>Table 2: Module 2 Conditions</b>	
<b>Time Drying</b>	3 hours 26 minutes
<b>Post-dry Weight</b>	7.159 kg
<b>Percent Moisture</b>	73.16 %
<b>Percent Mass Lost</b>	5.66 %
<b>Test Date</b>	March 30, 2022

In contrast with the first test, the flame did not rapidly spread across the canopy. Instead, several of the *Pachysandra terminalis* and *Thymus vulgaris* varieties caught fire early on, but the *Armeria maritima* and *Carex oshimensis* were left relatively intact. Additionally, the aforementioned plants did not catch fire as the same time. There were four flair-ups of fire on the canopy surface in the first 90 seconds of the test, which originated at the pilot flame.

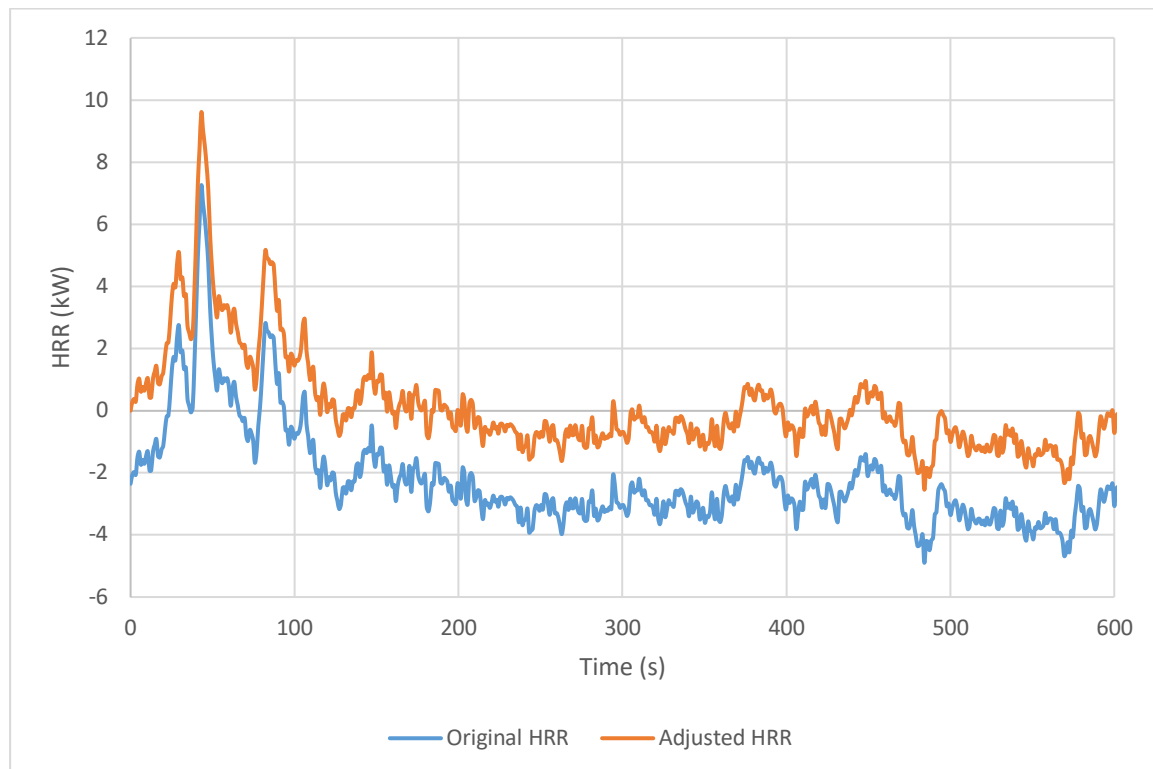
**Figure 39: Module 2 HRR**

this error is unknown, but a simple correction has been applied to the original data to set the HRR to 0 kW at  $t=0$ . This does not completely solve the problem, since the post canopy fire HRR is still partly negative. However, it is that largest net increase to the HRR that can be justified. The new peak HRR is 9.6 kW.

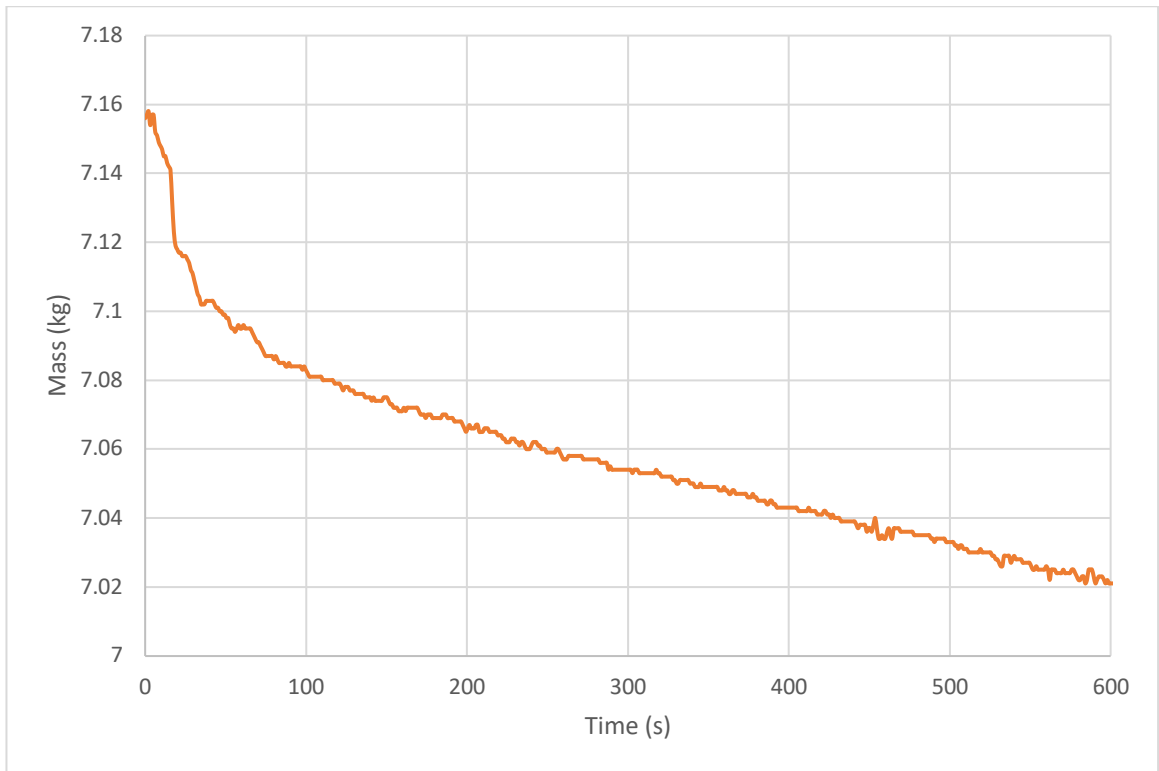
**Figure 40: Module 2 Mass**

The initial mass loss was very steep, similar to the module 1 test, despite a much smaller canopy fire. One potential explanation is some of the canopy material was separated from the plant by the flame and fell to the ground, removing its mass from the scale, but did not catch fire. The mass loss rate eventually settles at 0.118 g/s, which suggests that the soil was still able to sustain a smoulder, albeit less intense than module 1. This may be due to the higher moisture content of the soil. See Figure 39 and Figure 40 for details. Again, the test was unable to cause the module plastic to catch fire.

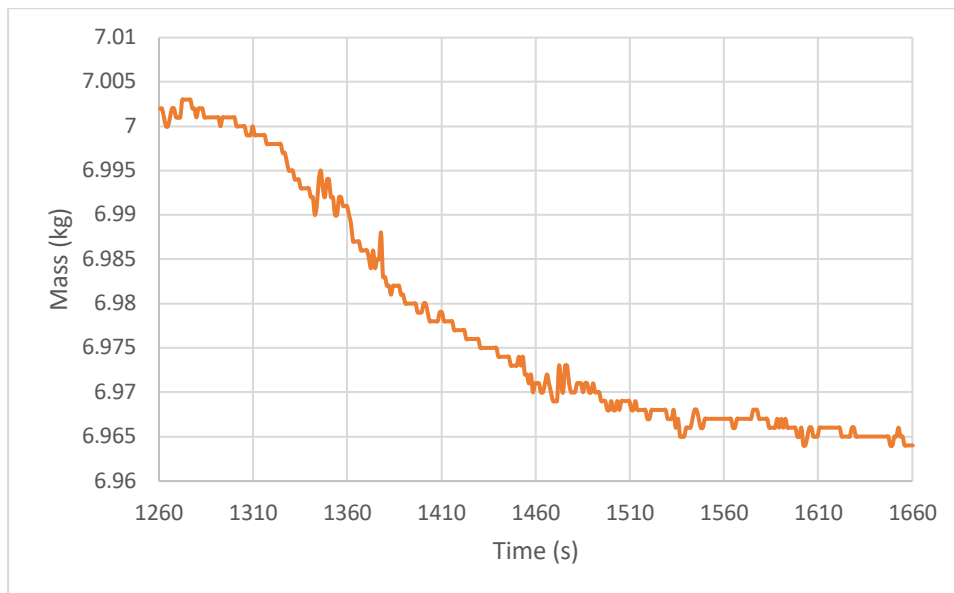
After the initial test concluded, the pilot flame was retracted, and then placed directly under the lower section of the plastic approximately 11 minutes later. After 2 minutes, the module had caught fire and the pilot was retracted again. This new flame was able to sustain itself for about 2 more minutes. The calibration error persisted through this portion of the test, so the adjusted value, using the same net increase as the previous test, has been included as well. There are still a fair amount of negative values, but the trendline appears to average out to approximately 0. The original peak HRR was 3.2 kW, and the adjusted peak was 5.5 kW. The mass loss rate during this period was approximately 0.2 g/s. See Figure 43 and Figure 44 for details.

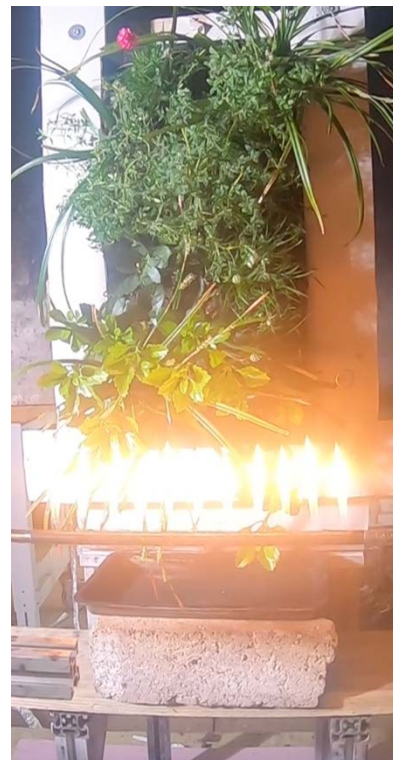
*Figure 46: Module 3, pre-burn*

This test module was intended to be used as the control test, so it was not dried out at all. Also, due to the large amount of falling material, a small tray was added below the module in an attempt to catch some of it. This was determined to be a more realistic scenario, since in a normal green wall installation, there would be a module below the burning one that could catch falling debris.

Table 3: Module 3 Conditions	
Time Drying	None
Post-dry Weight	5.81 kg
Percent Moisture	67.35 %
Percent Mass Lost	0.00 %
Test Date	March 31, 2022

In contrast with the previous two test, which had both been dried, this module did not exhibit any flame spread on the canopy when the pilot flame was first applied. Instead, the lower two rows of plants had their stems destroyed by flame and fell to the floor, mostly missing the tray. The upper plants were wilted by exposure to the pilot flame gases, and the thyme caught fire 8 minutes into the experiment. However, this flame did not spread to any of the

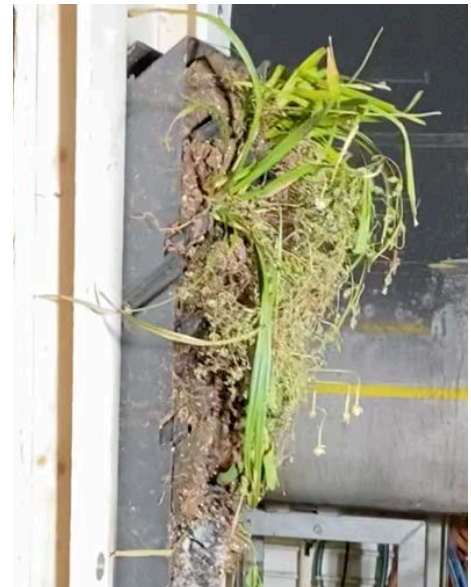
**Figure 50: Module 3 Test B Post-dry**

<b>Table 4: Module 3 Test B Conditions</b>	
<b>Time Drying</b>	50 minutes
<b>Post-dry Weight</b>	5.37 kg
<b>Percent Moisture</b>	65.57 %
<b>Percent Mass Lost</b>	1.81 % (7.71 % from pre-test mass)
<b>Test Date</b>	March 31, 2022

Unlike the previous test, there was some flame spread over the canopy this time. However, it was mostly limited to the *Pachysandra terminalis* and *Thymus vulgaris* varieties. The *Armeria maritima* and *Carex oshimensis* were left relatively intact, similar to the module 2 test. Again, the flame was unable to spread to the module, but some smouldering of the soil did occur.

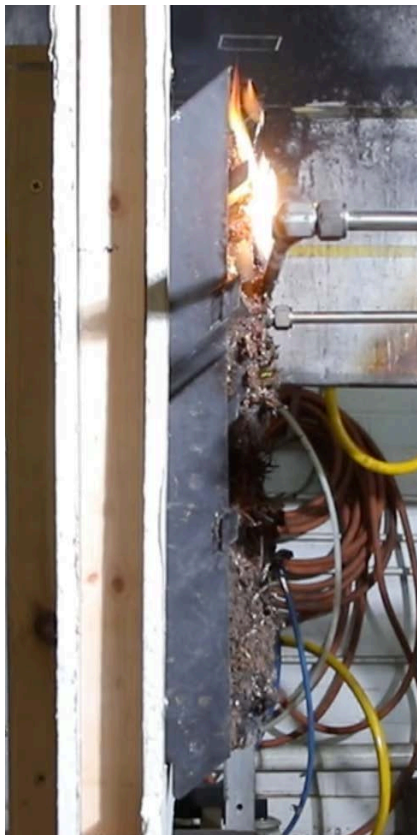
**Figure 59: Module 4 Test B Setup**

pushed forward so that it was in direct contact with the soil and module. See Figure 59 for a photo of the test setup.

Unfortunately, this test required the pilot flame to make physical contact with the module in order to spread effectively. This interfered with the mass for the portion of the experiment in which it was engaged. However, it was withdrawn after 8.5 minutes, and the flame was able to sustain itself for another hour. Using the mass readings immediately before and after the pilot flame was in use, the mass loss during that time was determined to be 0.093 g/s. This is considerably lower than the mass loss experienced by the other modules, but this one did not have the canopy fire to accelerate the smouldering. Also, only one and a half cells were exposed to the pilot flame and its hot gases, due to the change in elevation, as opposed to all 6 cells when the pilot flame is at the bottom of the module. The mass loss

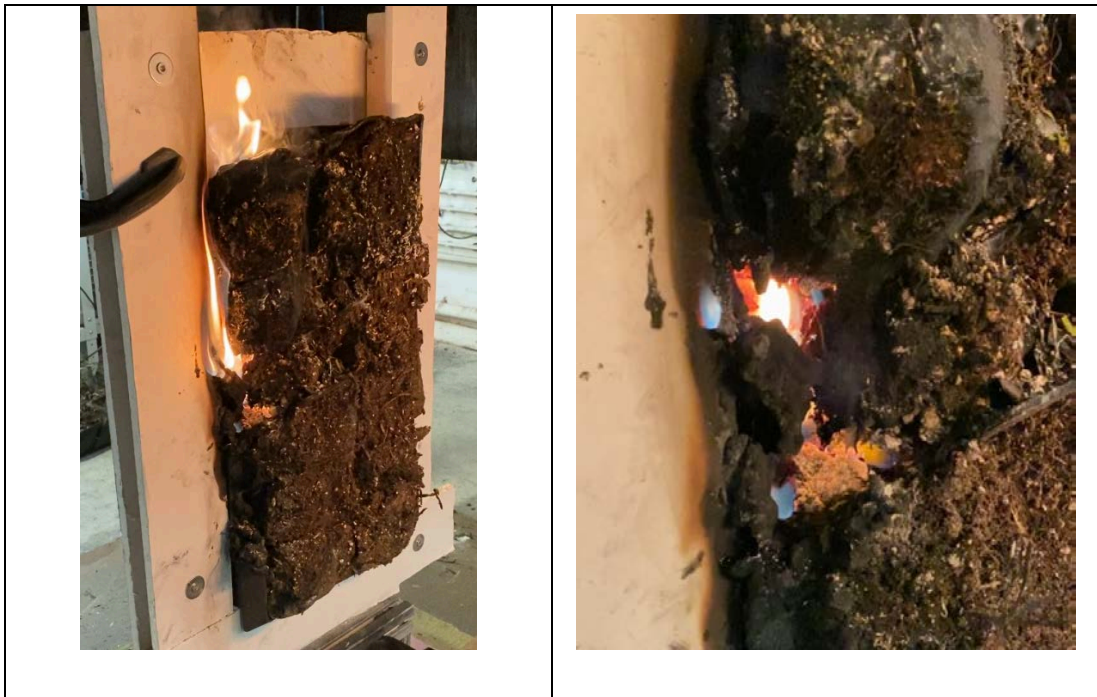
**Figure 62: Post-breakthrough Fire**

After this point, the size of the fire began to increase considerable. Based on visual observation, this produced the largest flame and smoke production that did not come from a canopy fire. With the fire burning on the inside of the cavity, it had access to all of the plastic fuel that made up the back of the module. It also began to pyrolyze the surface of the wooden support. The exact contribution of the wood to the overall mass loss is not known. See Figure 62 for photos of the fire shortly after the clamp was installed.

During this portion of the experiment, the mass loss rate increased significantly. The noise from the addition of the clamp makes it slightly harder to get an exact number, but an analysis of the stable sections of the data at 2789 s and 3052 s suggest a mass loss rate of 0.31 g/s, which was is the highest recorded up to that point. This mass loss rate began to slowly decrease as the cavity fire died down. After an hour of testing, the fire had shrunk considerably and the experiment was ended. The fire did not compromise the structural integrity of the module itself.

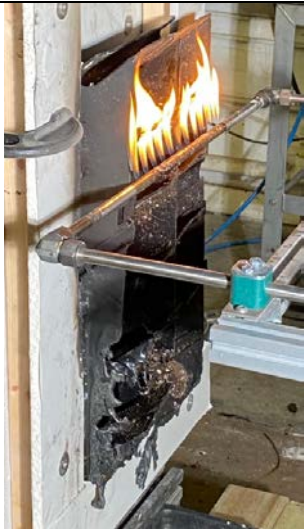
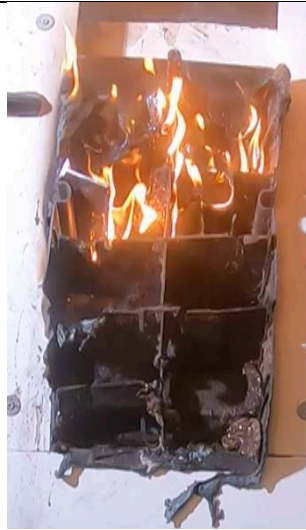
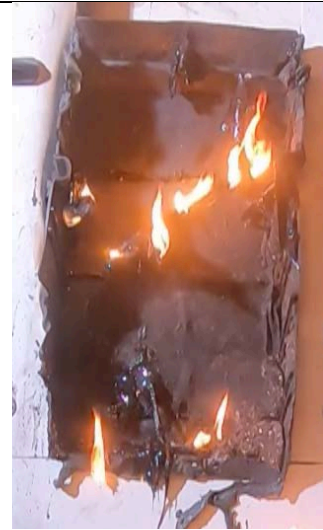
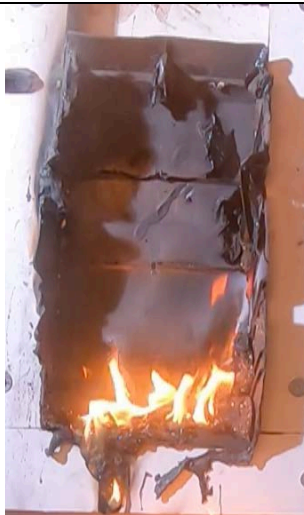
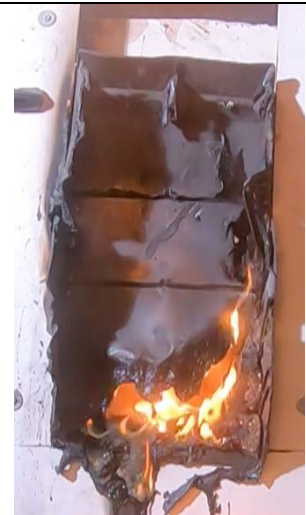
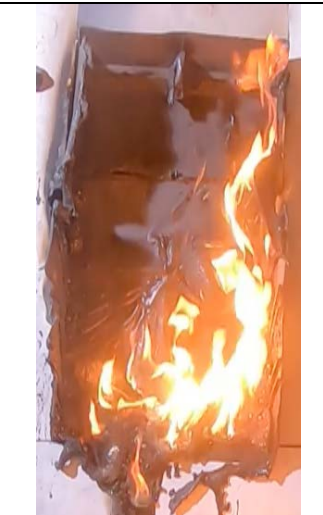
Having observed the effects of a high elevation fire on a module with soil in it, this experiment was planned to observe the effects of a similar fire on a module without any soil. By that point, all four of the modules had been used in experiments, so module 2 was selected because the upper cells were relatively intact. The soil was then removed from the cells and it was re-installed on the testing apparatus. The test followed the same procedure as Module 4 test C. See Figure 63 for a photo of the test setup.
