# Appendix

## Case studies of some infamous incidents

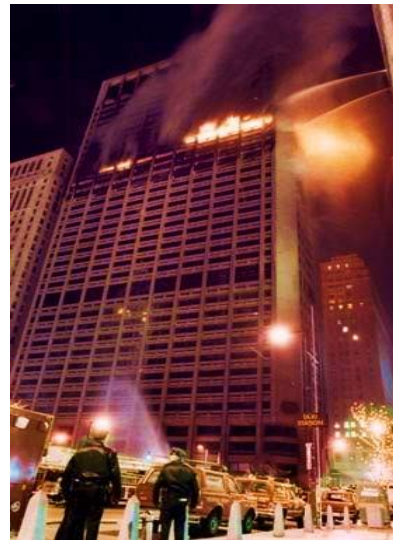
*Figure 34 One Meridian Plaza fire*

1. **The One Meridian Plaza fire in 1991, Philadelphia** – The fire ignited on the 22nd floor of the building. As reported, only three people were present, who were involved in the job of refinishing wood work. The fire was started in the pile of rags which were soaked in the linseed oil (Chubb, Jennings and Routley 1991).

The building's construction materials also contributed to the severity of the fire. The building was constructed with a curtain wall, which is a non-load-bearing exterior wall made of glass and metal. This type of construction allowed the fire to travel vertically up the building's exterior and spread quickly through the floors. In this unfortunate incident, 3 firefighters lost their life after being trapped in the building's stairwell during the fire. The firefighters were exposed to high levels of smoke and heat during their attempts to extinguish the fire and evacuate occupants from the building.

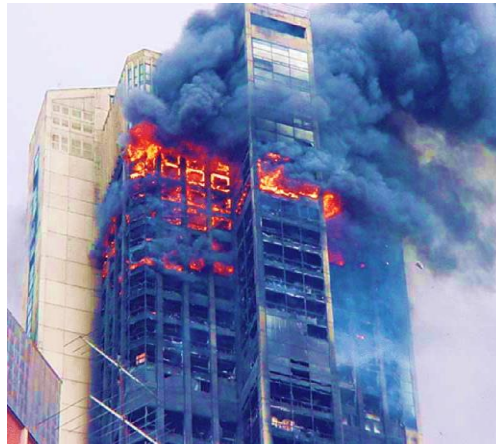
*Figure 35 Caracas tower fire, Dubai*

2. **The Caracas Tower fire in 2004, Venezuela** – The Caracas Tower fire occurred on October 17, 2004, in Caracas, Venezuela, and resulted in the deaths of at least 17 people. The fire started in the building's electrical room and quickly spread to the upper floors due to the lack of fire-resistant materials in the building's construction. (Moncada March/April 2005)

One of the primary reasons for the evacuation failure here was the lack of an effective evacuation plan and proper training for building occupants. The fire alarm system in the building did not function properly, and the public address system was inadequate, which made it difficult to notify building occupants of the fire and give them instructions for evacuation. Additionally, the stairwells in the building were not clearly marked, and some were obstructed, which hindered evacuation efforts. Another factor that contributed to the evacuation failure was the building's design, which had limited escape routes. The building had only three

stairwells, and they were narrow, making it difficult for occupants to evacuate quickly and safely.

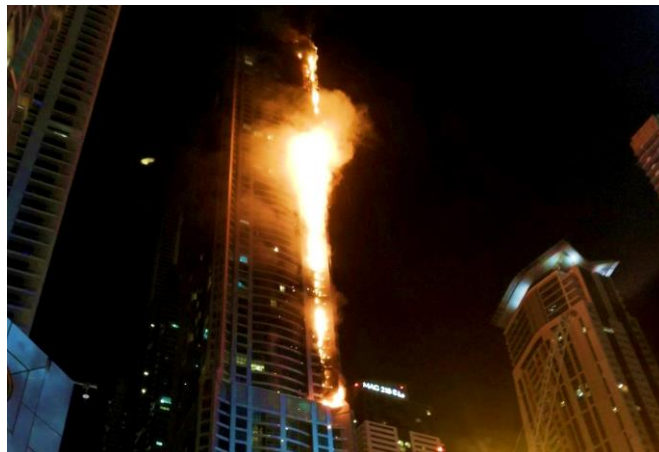
*Figure 36 Torch tower fire, Dubai*

- 3. The Torch Tower fire in 2017, Dubai** – The reported cause of the fire was a faulty electrical wiring in one of the apartments on the ninth floor. The fire quickly spread up the building's exterior cladding due to the strong winds and combustible cladding material, which contributed to the severity of the fire. A delay in the evacuation was observed in this case because a proper emergency evacuation plan was not in place and a communication gap was observed between the firefighting team and the occupants.

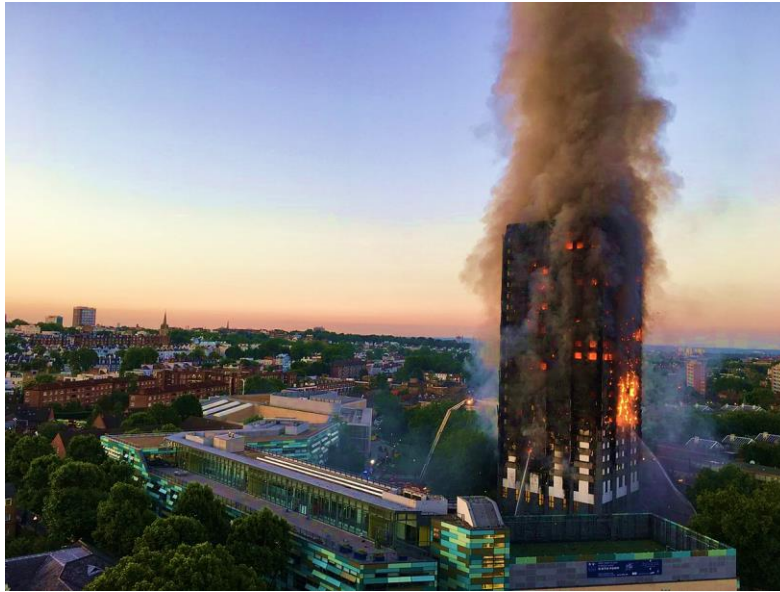
*Figure 37 Grenfell tower fire, London*

4. **The Grenfell Tower fire in London, England in 2017-** The infamous Grenfell tower fire incident occurred on June 14, 2017, in London, England. The fire broke out in the 24-story building, causing the deaths of 74 occupants. The fire reportedly began in a refrigerator-freezer in one of the flats on the fourth floor and rapidly spread up the outside of the building due to the building's cladding system. The cladding, which was installed during a recent refurbishment of the tower, was made of flammable material.

The other main reason of such large number of casualties was to have the “Stay Put” strategy. The "stay put" strategy instructed by the firefighting team to occupants to remain in their apartments unless they were directly affected by the fire, but in this case the strategy totally failed. The fire spread rapidly throughout the building, largely due to the combustible cladding. The fire spread between apartments and compartments, and the building's design and construction did not contain the fire as intended.
