Performance of joints for glued laminated timber exposed to the ISO fire temperature curve

Report 5638, Lund 2021

Master thesis in fire safety engineering

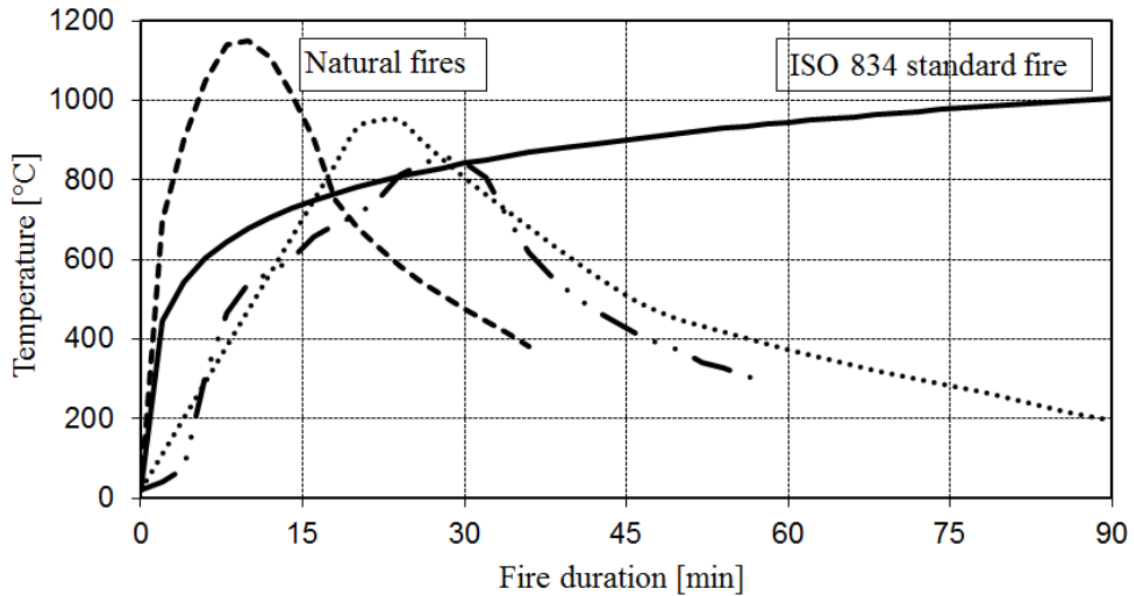
In the picture below some natural fire curves are compared to the ISO 834, for the first minutes one of the natural fires surpasses the temperatures provided by the standard. However, once the decay phase starts to set in, the behavior of the standard fire curve becomes the most severe. This shows some of the difficulties present when comparing the results of a standardized test and the results of an actual fire.

Figure 8. Fire curve for some natural fires and the ISO 834 [42]

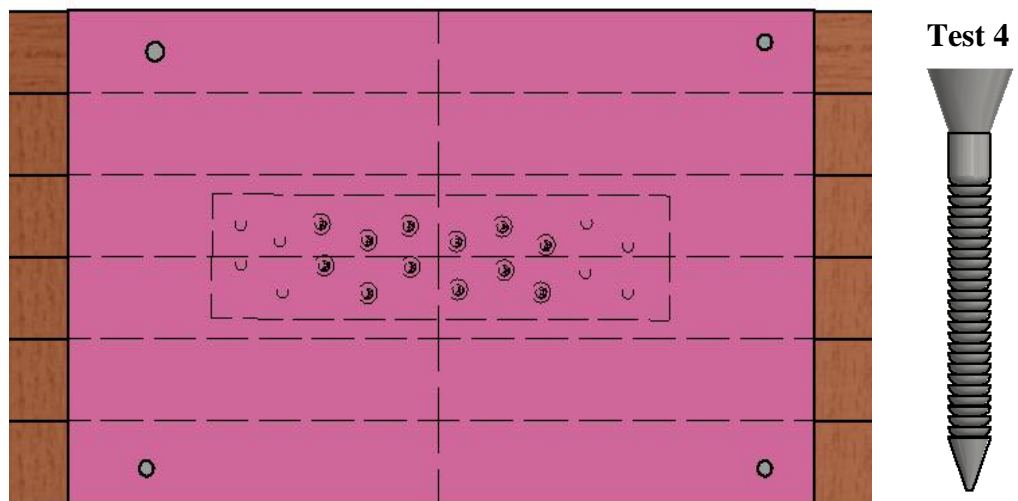
Figure 17. Joint sections for the four different configurations tested

1. A 50 mm x 200 mm x 2 mm Plate joint using shank nails as a mechanical fastener
2. A 80 mm x 200 mm x 2 mm Plate joint using shank nails as a mechanical fastener
3. A 50 mm x 200 mm x 2 mm Plate joint using self-tapping screw as a mechanical fastener
4. A 50 mm x 200 mm x 2 mm Plate joint using shank nails as a mechanical fastener protected by a 12 mm gypsum board

All plates used were Simpson Strong-Tie branded and manufactured out of galvanized steel with a yield strength of 250N/mm^2 and an elongation before rupture of 19%, for the 50 by 200 mm plates only 12 out of the 20 holes were used to hold fasteners, the rest were left unused, to register the effect of using a bigger plate the 80 mm by 200 mm plate was also assembled using 12 fasteners in the same geometrical configuration as the smaller plate.

For each specimen two plates were used, one on the top and one on the bottom, the purpose of the use of two plates was to diminish any bending produced by the inherent eccentricities of the system. To simulate the average conditions in a construction site, no predrilling was used for the embedding of the nails or the screws.

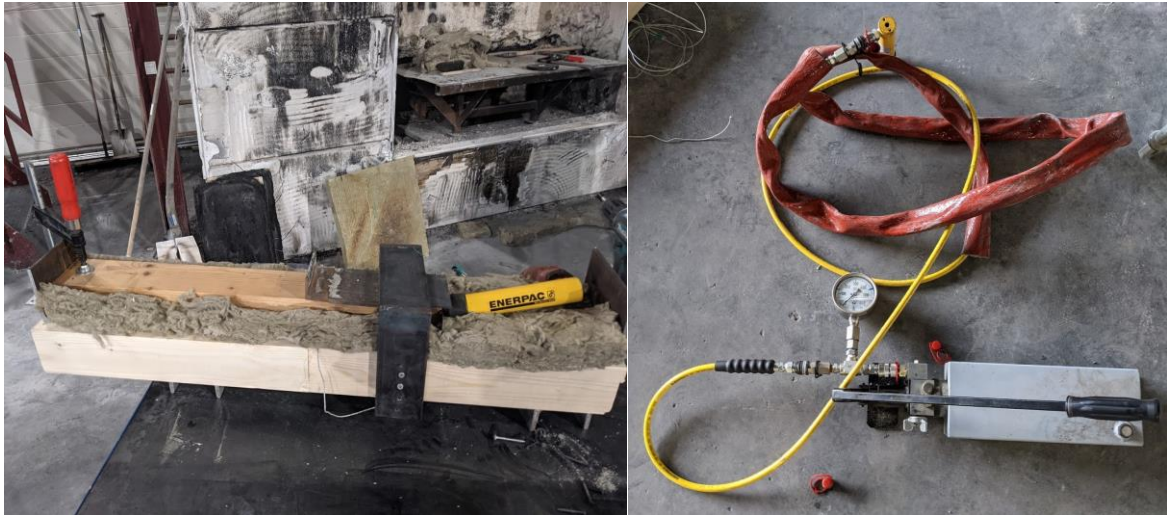
Figure 18. Experimental setup and jack system

Additionally the system was also fitted with a steel brace on top of the timber bar, this steel brace had the purpose of preventing any vertical movement from the jack or the bar produced by the eccentricity of the forces; to reduce friction a metal plate with a rolling pin was installed on the timber bar.

Once the jack was placed and secured a pressure of 80 bar with an equivalent load of 4.2 KN was applied using the manual pump.

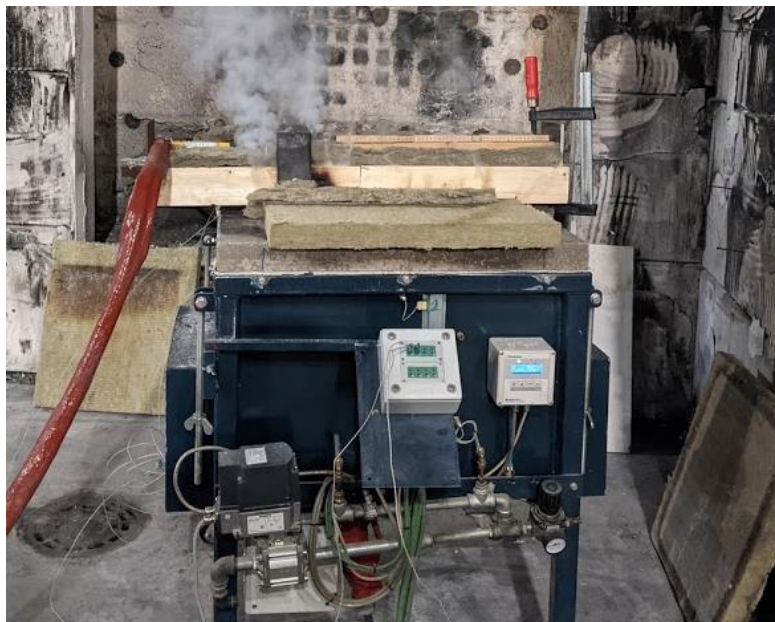
Figure 21. Specimen 1 exposed to the fire curve

Once each test started the gap between the glulam pieces in the joint were measured to see any possible displacement produced. In the first test, a ruler was placed on top of the test sample but the smoke created during the test did not allow for an accurate reading of this gap from a distance, so instead in the rest of the tests a measurement of the distance was recorded every 7 minutes by positioning a ruler directly in the upper gap of the samples and recording the dimensions of the gap.

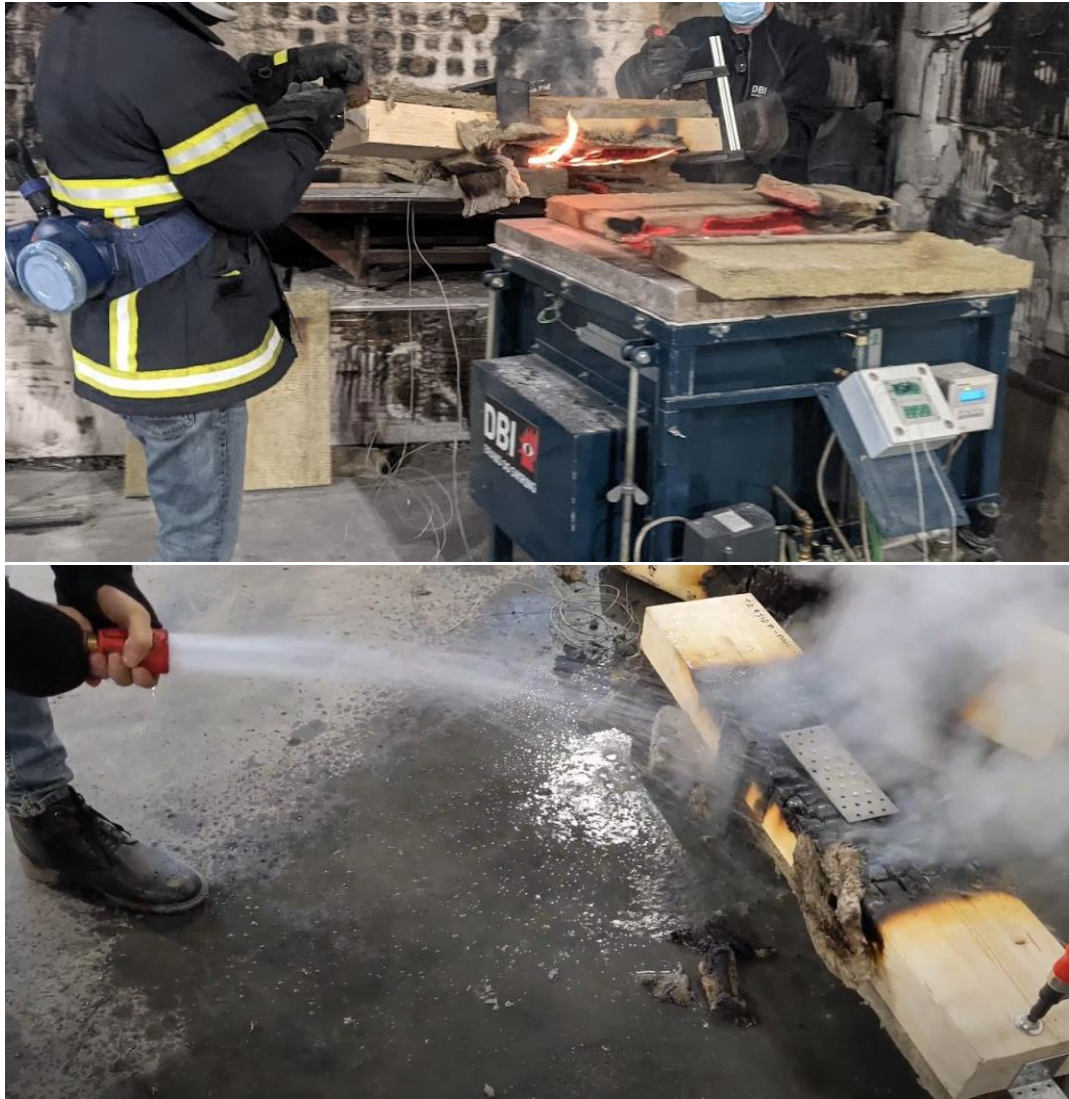
Figure 22. Removal of test sample 1 from the oven (top), extinguishment of sample 2 (bottom)

Since the glulam members are composed out of combustible material this meant that even after their extraction from the oven, flames could still be seen on the exposed area, as to prevent further charring a water hose was used to extinguish any visible flames, the pressure on the hose was kept at a minimum as to prevent any water damage that could harm any results produced by the fire test.

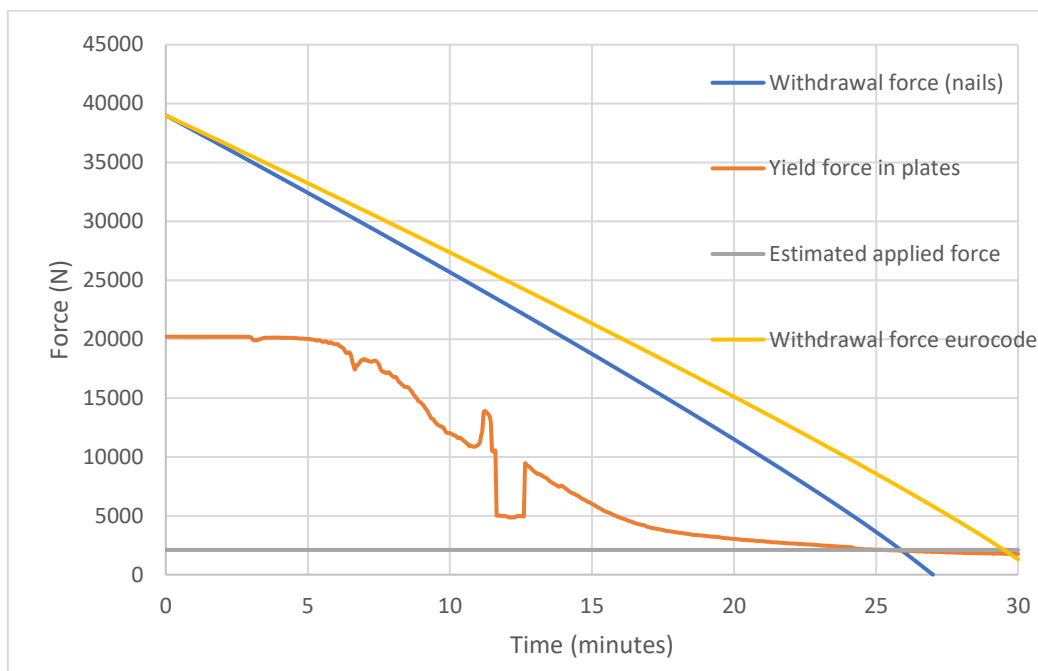
Figure 39. Yielding, withdrawal, and applied forces during the ISO 834 for test 1

In Figure 39 we can see the forces necessary for what would be considered failure in a mechanical assembly, either the release of the mechanical fasteners or the yielding of the exposed plates. Just like it was seen in Figure 32 we can see the pullout force reduction due to the losses in the effective depth of the nails, in this case however it is also possible to see and compare how the yielding force is also diminished during the testing.

The loss in the yielding strength reaches the applied force at around 24.8 minutes and close to a minute before the withdrawal total loss of strength, meaning that by this time the joint was being held down mostly by the upper plate.

In the former picture the loss of mechanical resistance due to the loss of timber in the unjointed area was not added as the values for resistance in tension for cold conditions and during the fire scenario are much higher. This is portrayed in Figure 40.

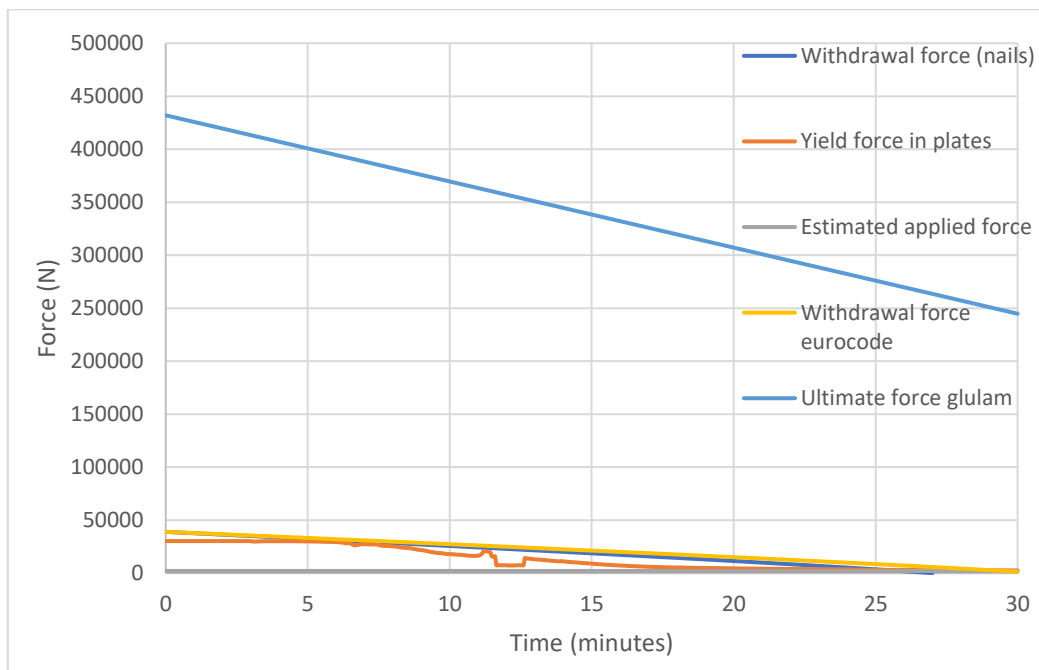
Figure 40. Yielding, withdrawal, glulam tensile failure, and applied forces during the ISO 834 for test 1

When compared to the loss of strength of the samples due to the reduction of the timber area it is possible to observe that the reduction of it is linear and at lower pace that for the plates and the mechanical fasteners, for example by minute 15 glulam remains at 79.5 % of its strength while at the same time the total withdraw force was at 49.5 % of his maximum and at 28.59 % for the plates. This signals that in this setup the point of failure would be the joints not only due to the smaller overall resistance but also the speedier loss of their mechanical attributes during heating.

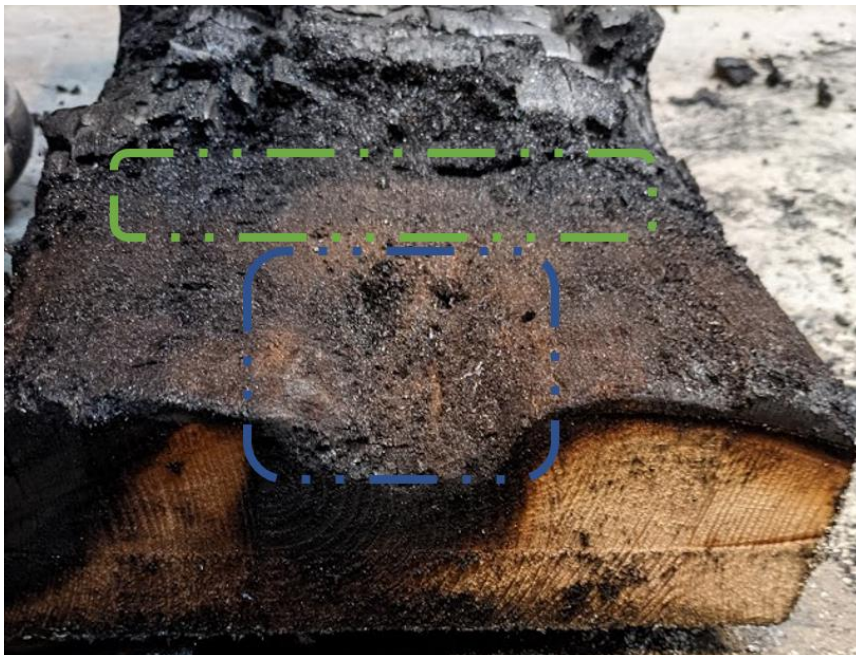
Different zones used to measure the charring rate

For the charring rate measurement two different zones were measured one just below were the plate and the fasteners were installed (represented by blue in the next picture) and the section that was exposed but did not had any fasteners or joint attached.
